BUREAU OF YARDS AND DOCKS WASHINGTON D C

AEC-WT-91

Since protective construction is a problem common to civil as well as military installations, practical methods of design and analysis for blast loadings must be developed for use by structural engineers. The method of design and analysis used in Project 3.2 was developed for practical use by A. Amirikian, Consultant on Special Structures for the Bureau. The complete postshot analysis for two of the most important structures may be found in Chap. 7. The remaining structures will be analyzed as time permits.

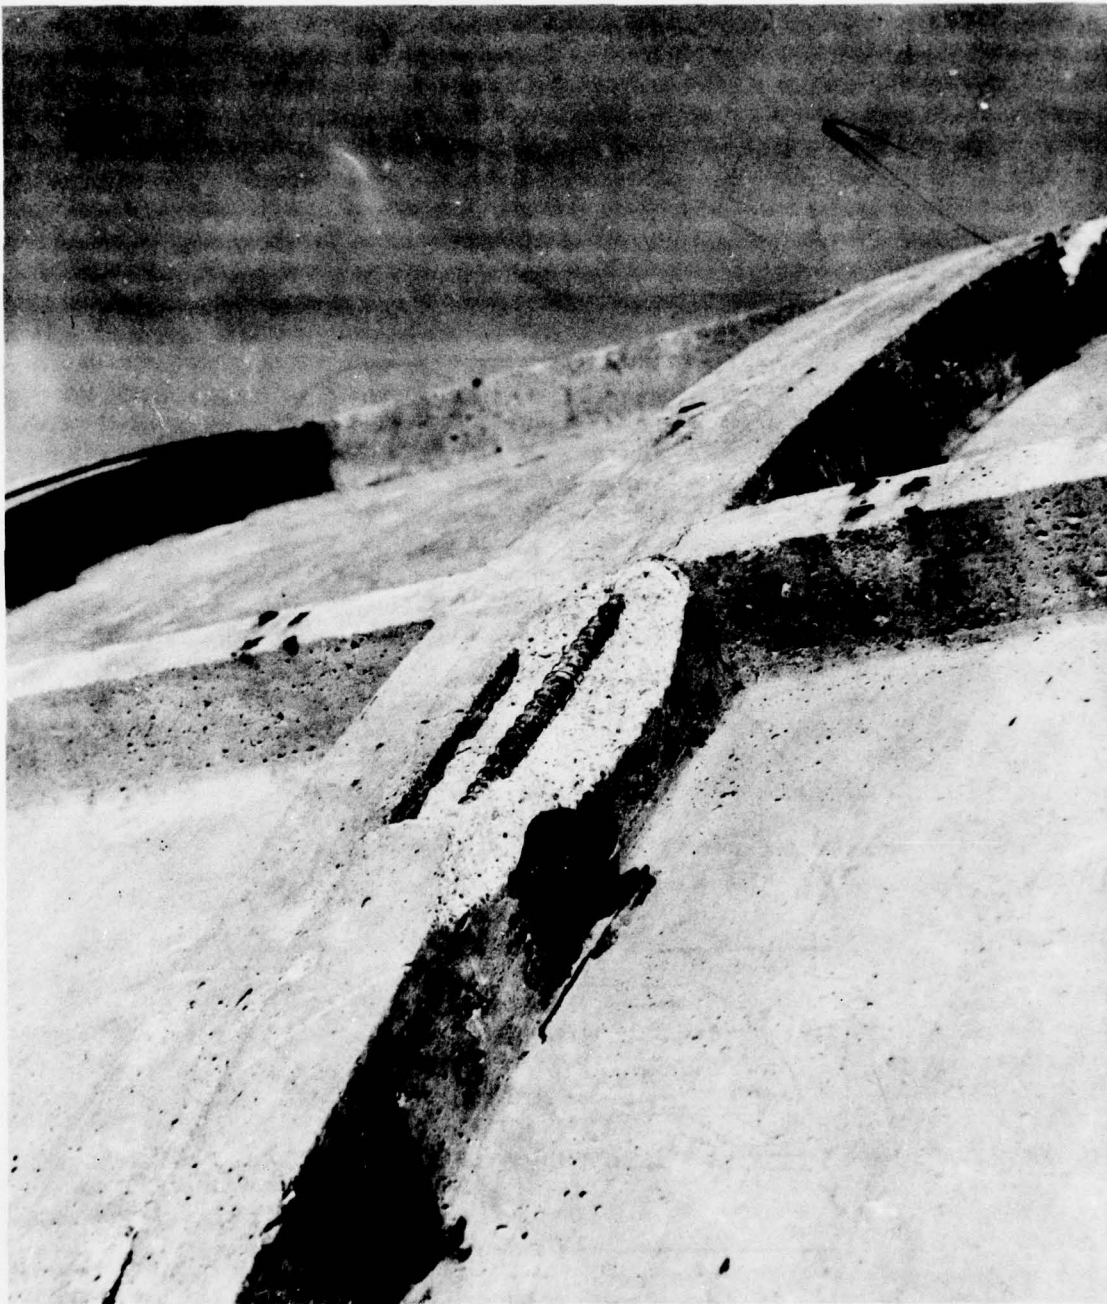
Fig. 6.91 Spalling in Rib of Rear Arch Panel, Structure 3.2.5

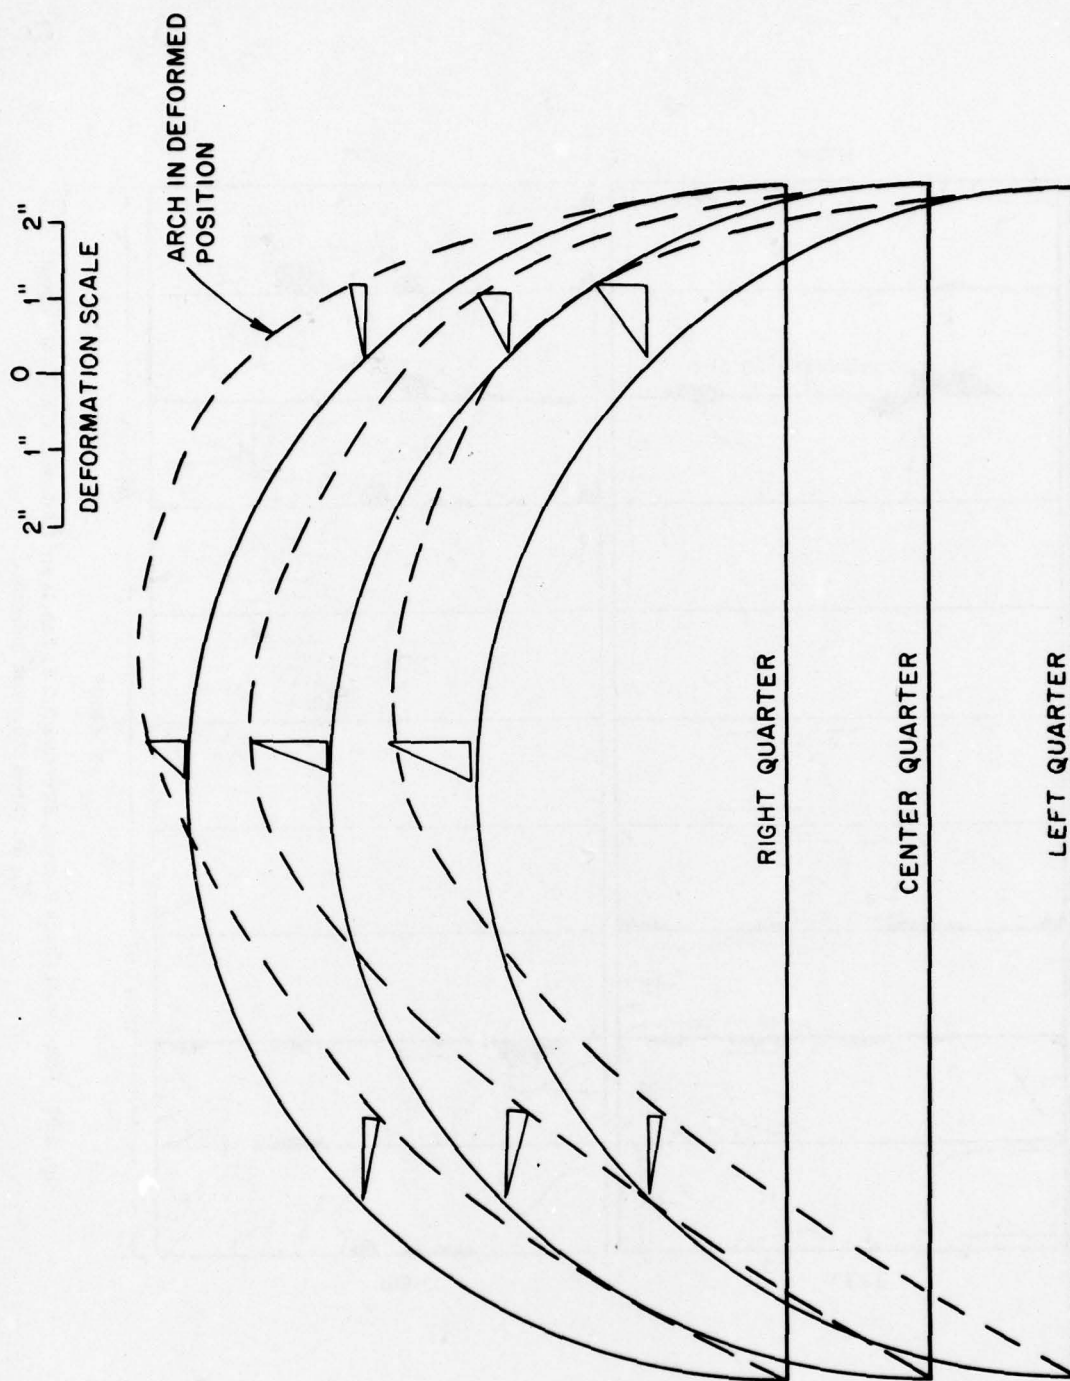
Fig. 6.96 Arch Deformation, Structure 3.2.5

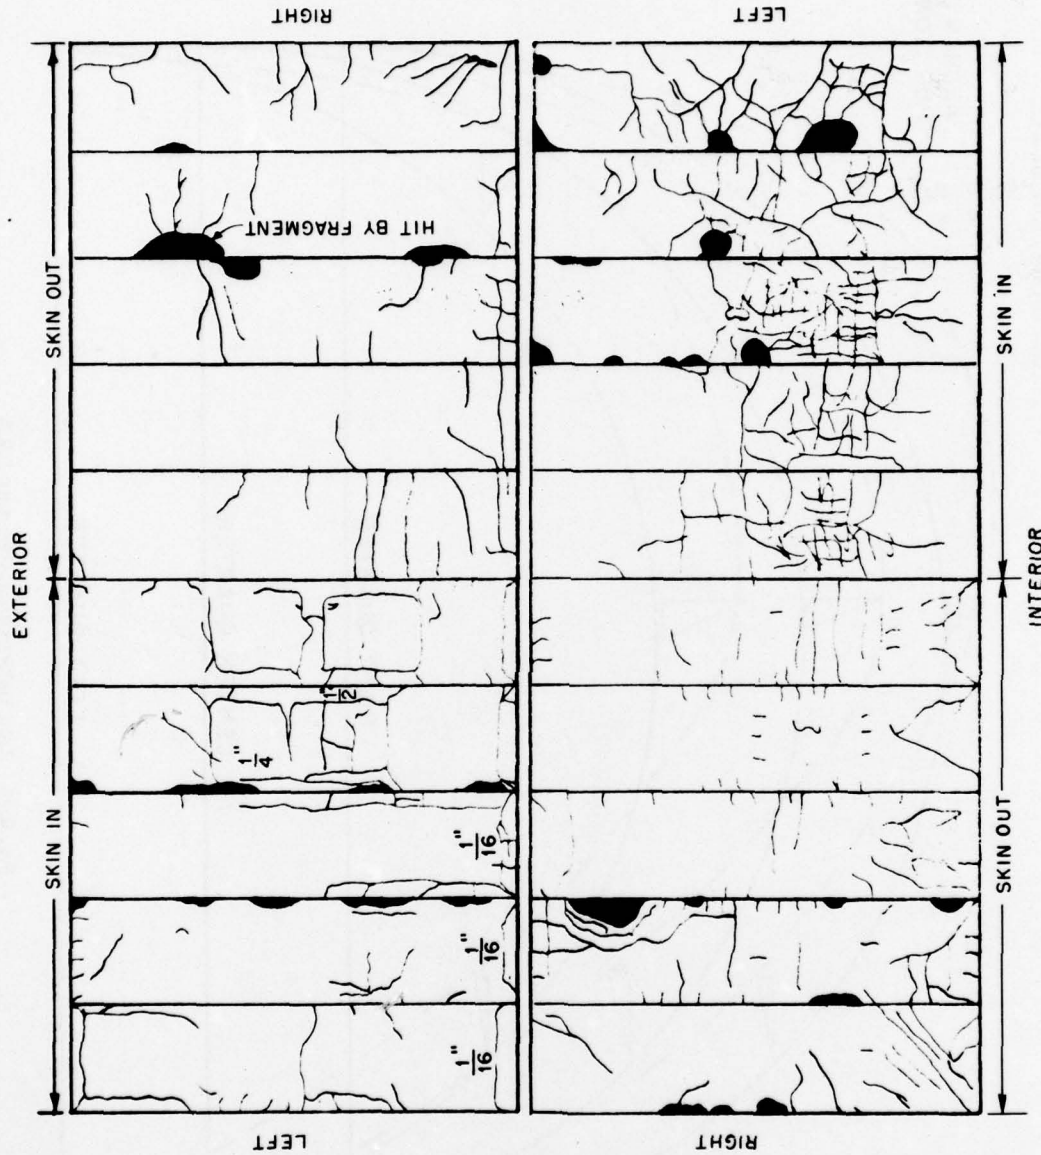
Fig. 6.97 Front-wall Crack Pattern, Structure 3.2.5. Panels are flattened. Cracks are about $\frac{1}{64}$ in. unless otherwise marked.

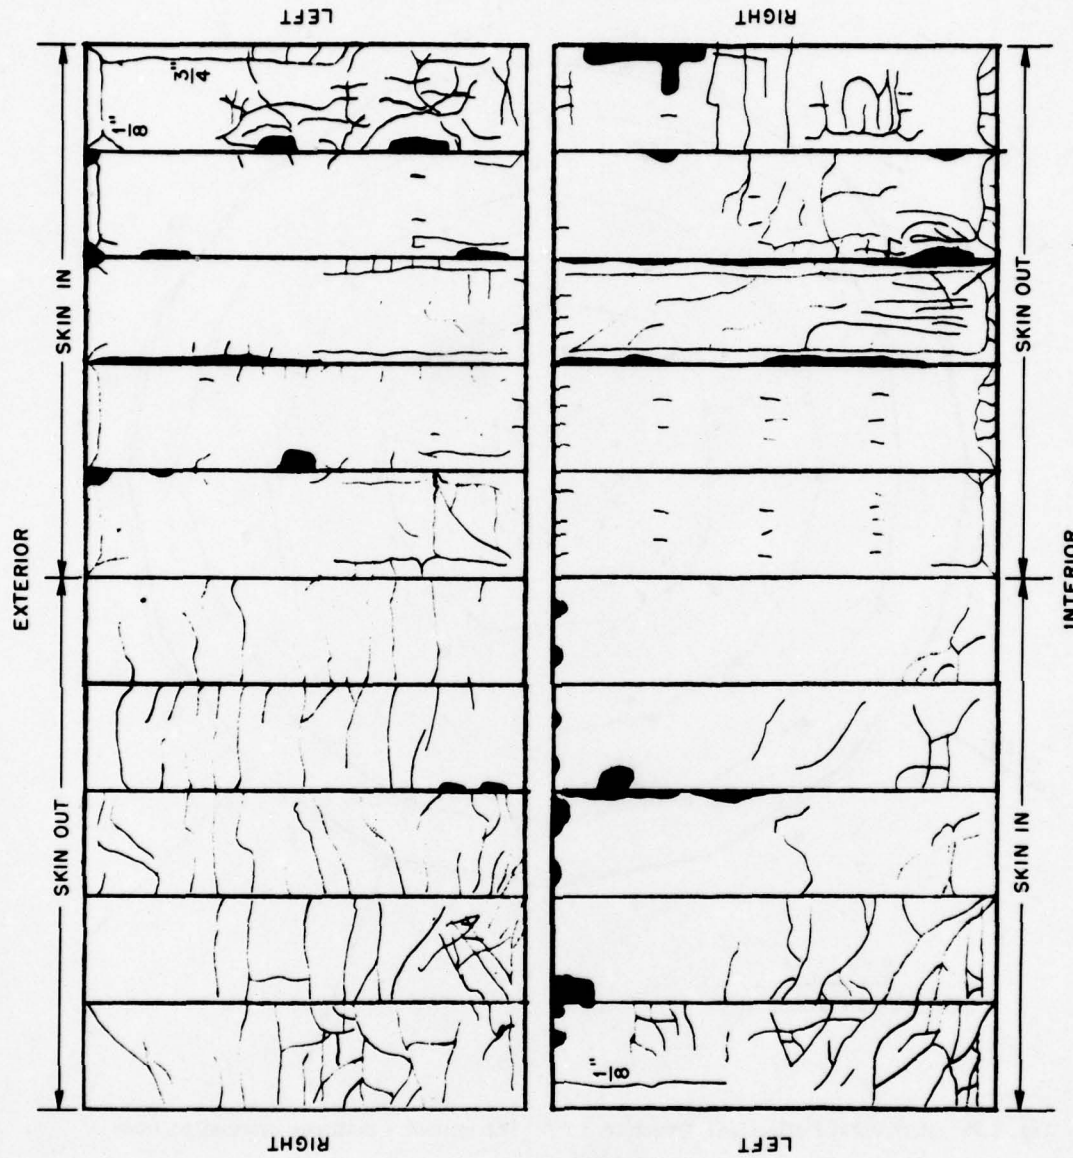
Fig. 6.98 Rear-wall Crack Pattern, Structure 3.2.5. Cracks are about $\frac{1}{4}$ in. unless otherwise marked.

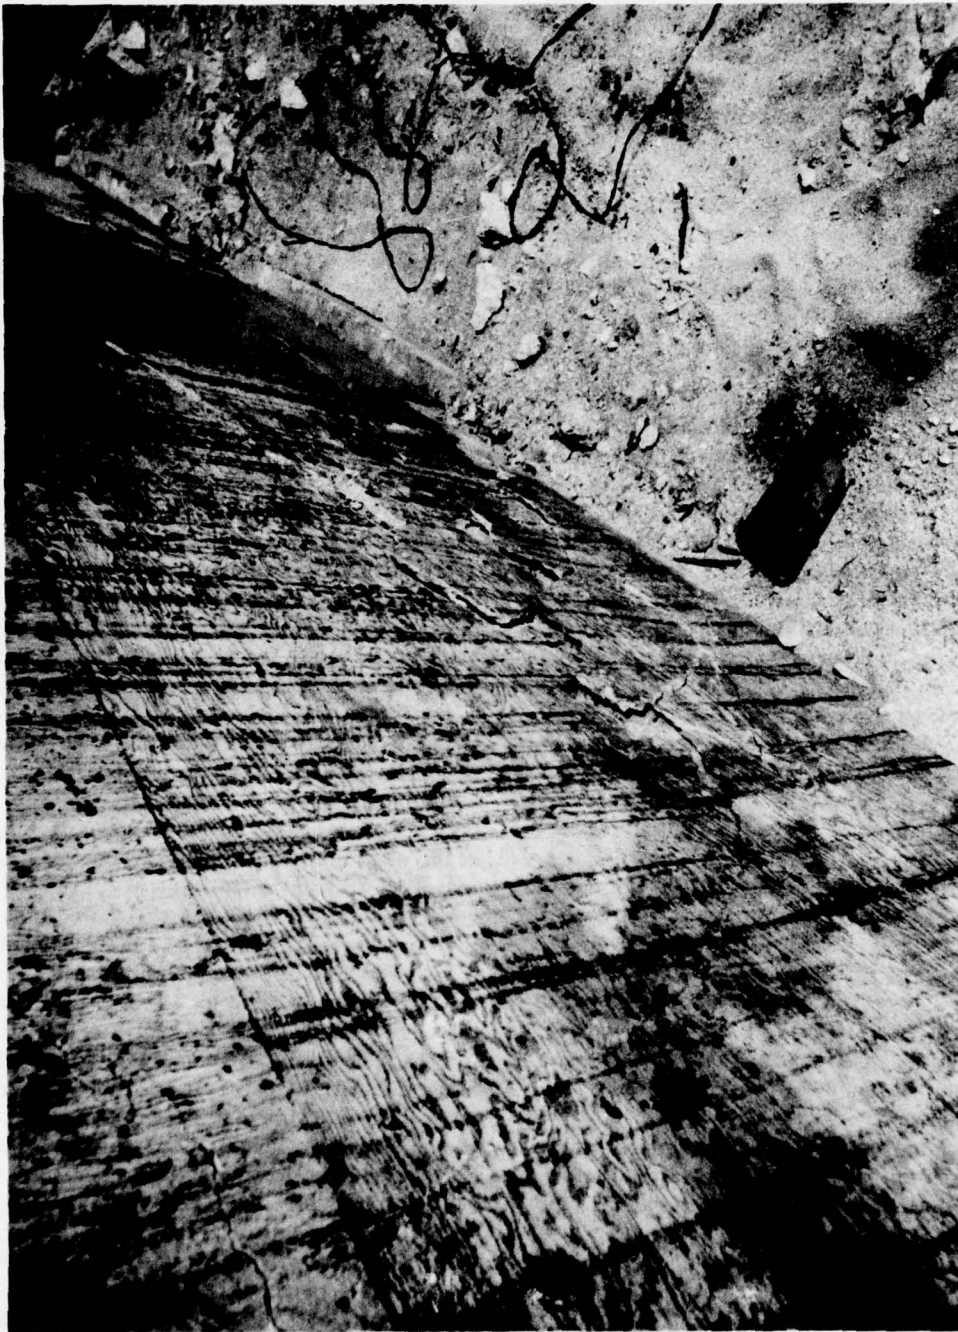
Fig. 6.102 View of Left End Wall from the Rear, Showing Shear-failure Cracks

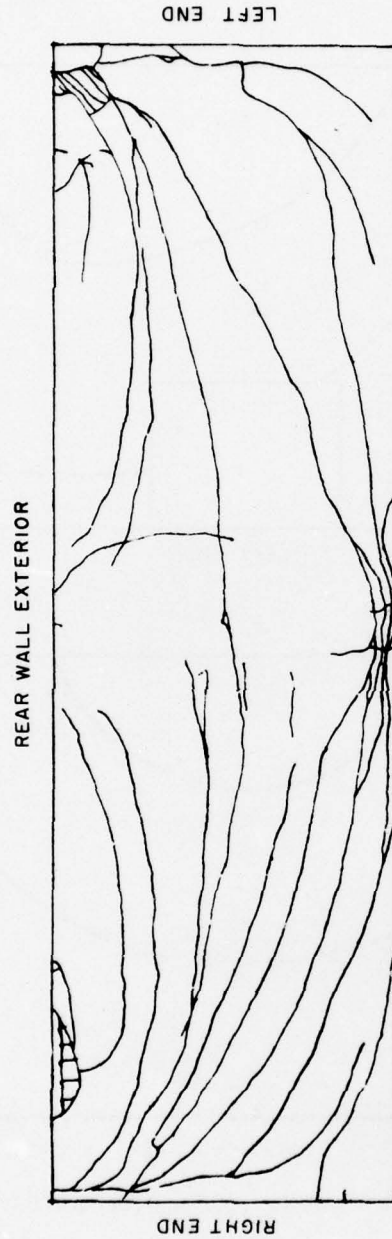
Fig. 6.105 Rear-wall Crack Pattern, Structure 3.2.7a

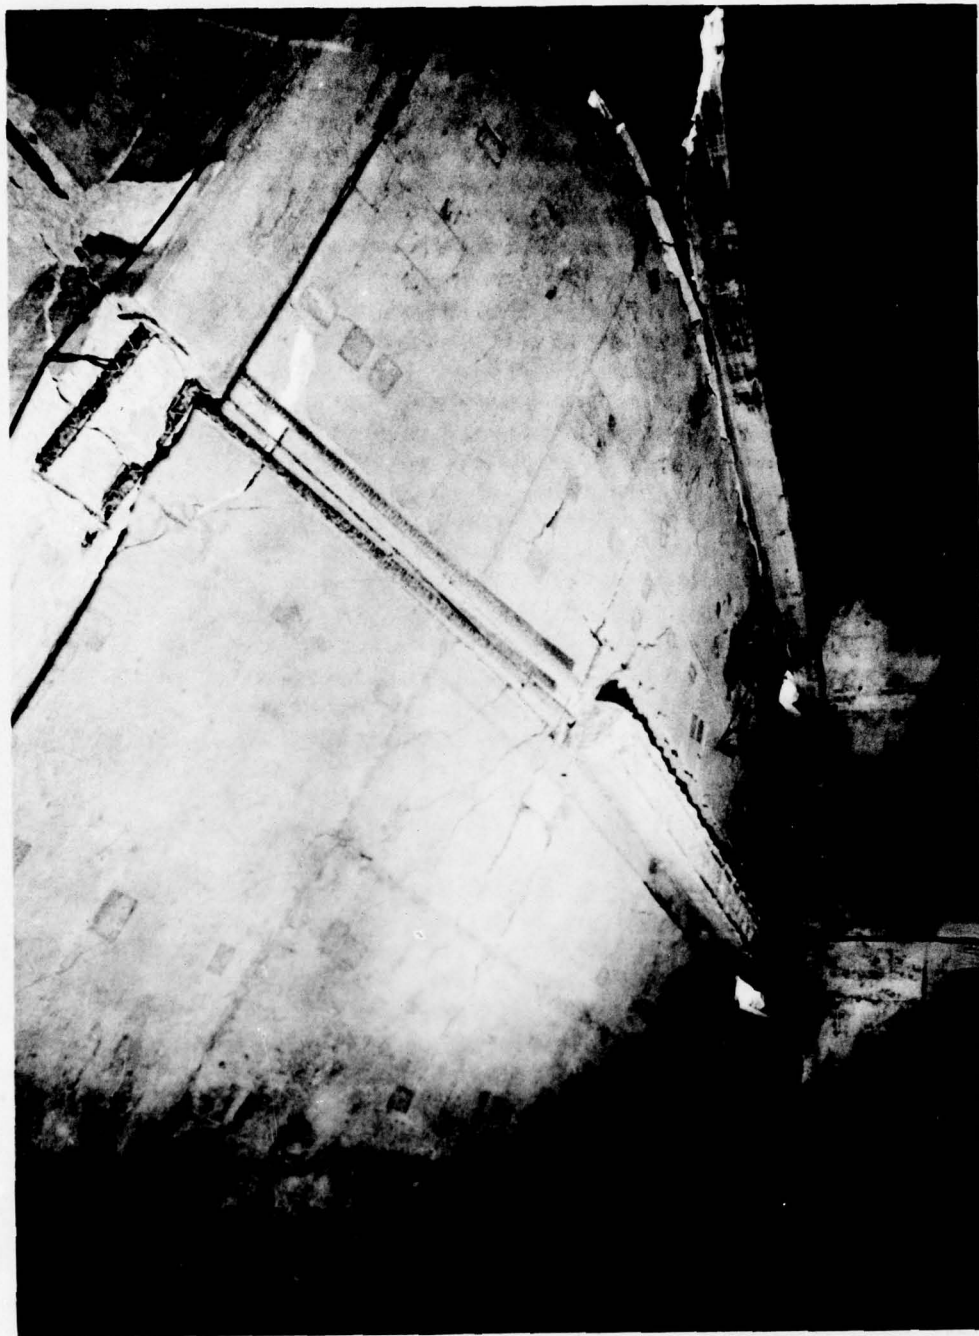
Fig. 6.107 Longitudinal Stringer Beams Under Right Half of Roof. Complete failure occurred.

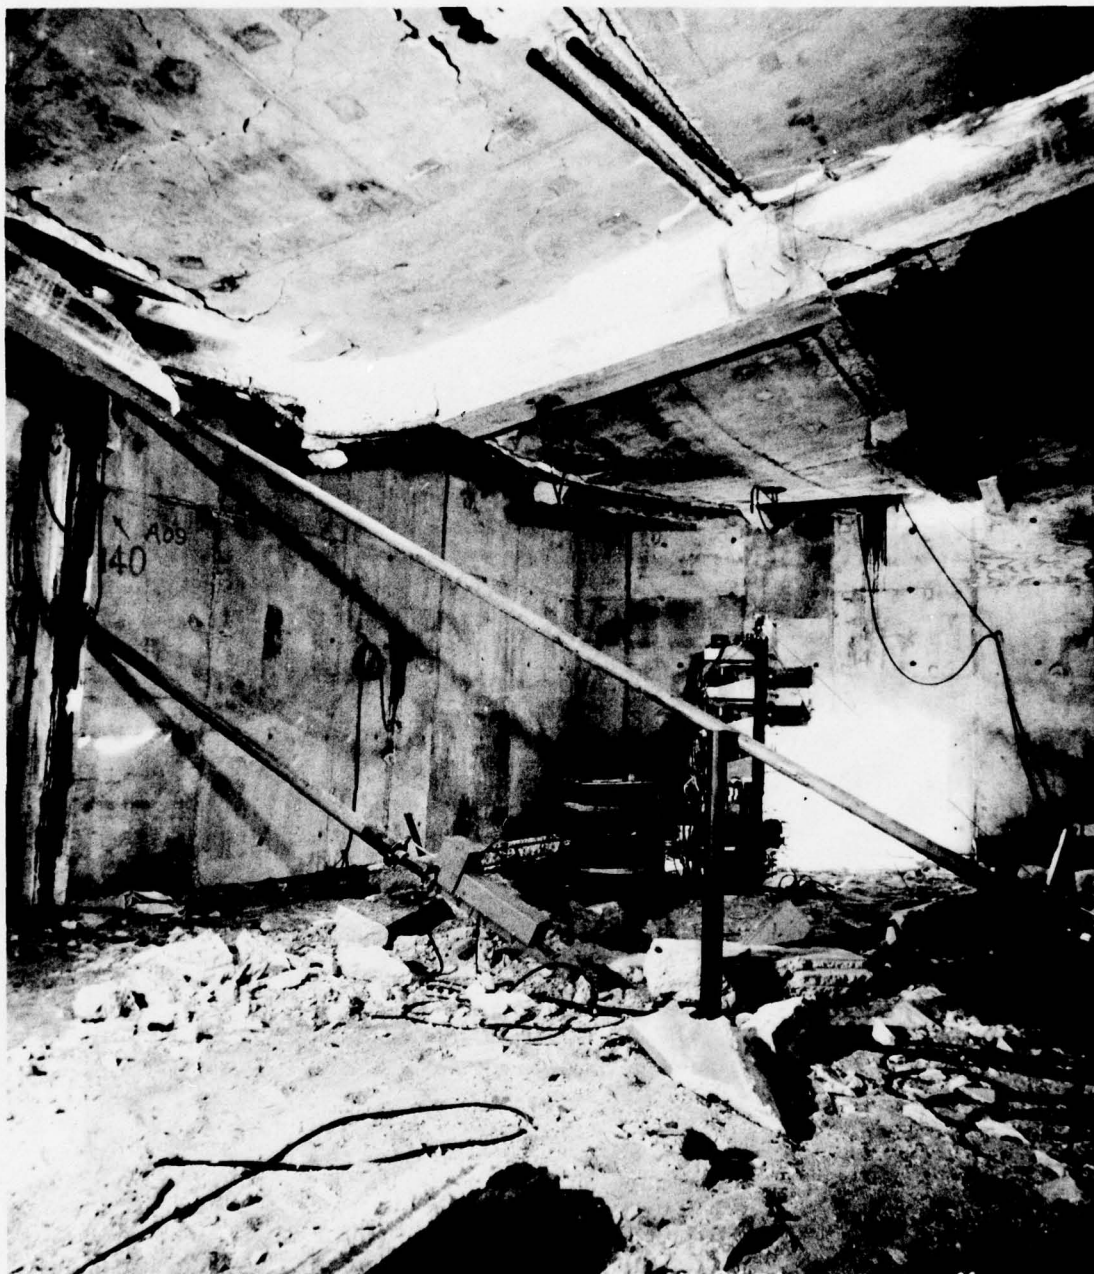
Fig. 6.108 Deflection of Main Transverse Roof Girder. Lower sections of the small longitudinal stringer beams are lying on the ground below the beams.

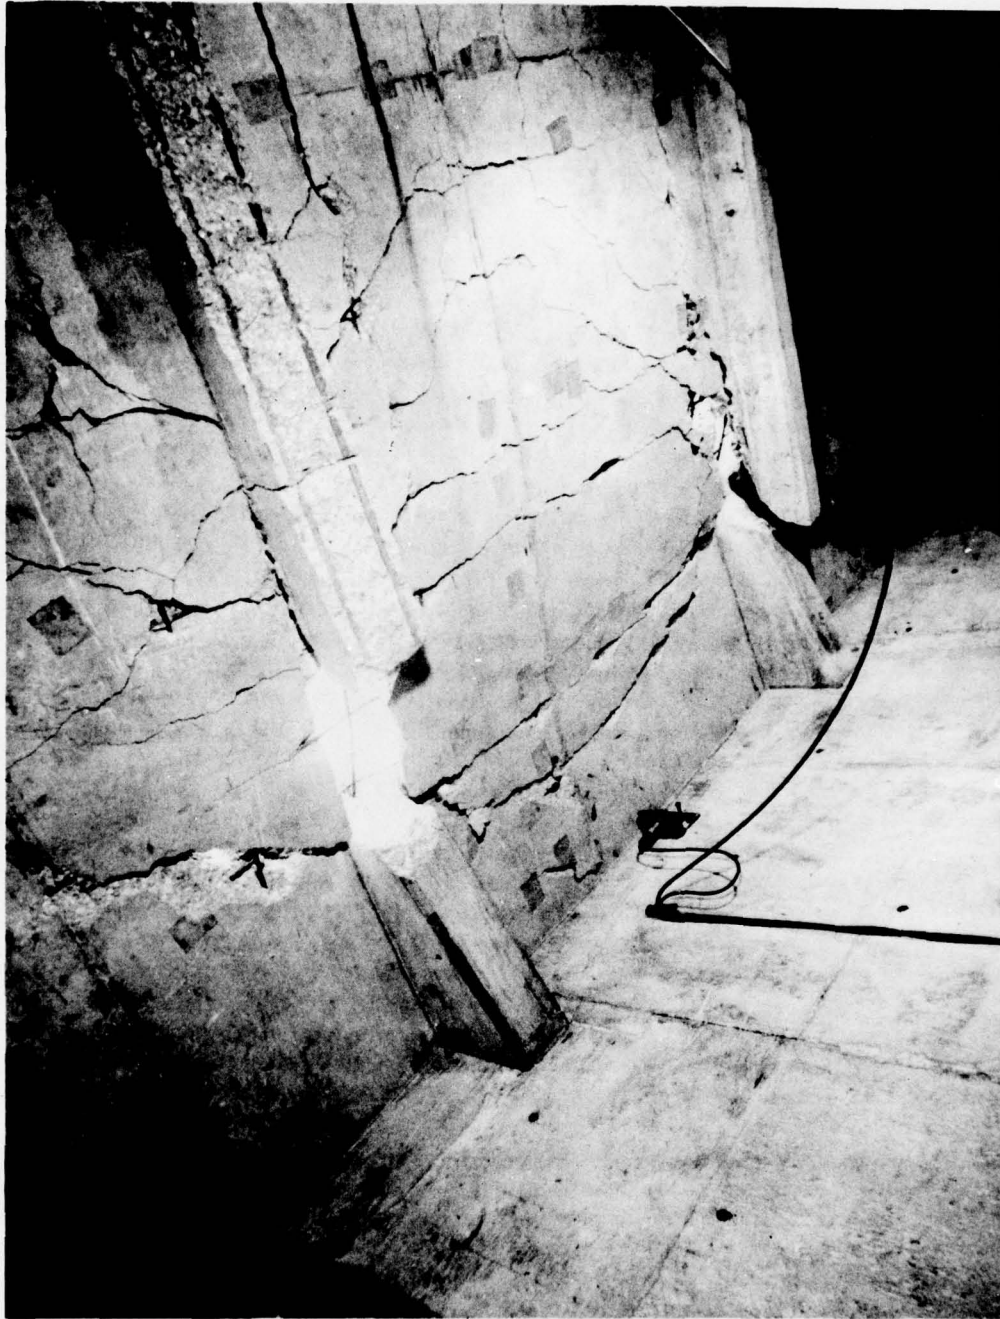
Fig. 6.109 Detail View of Diagonal Tension Failure of Stringer Beams at the Haunches

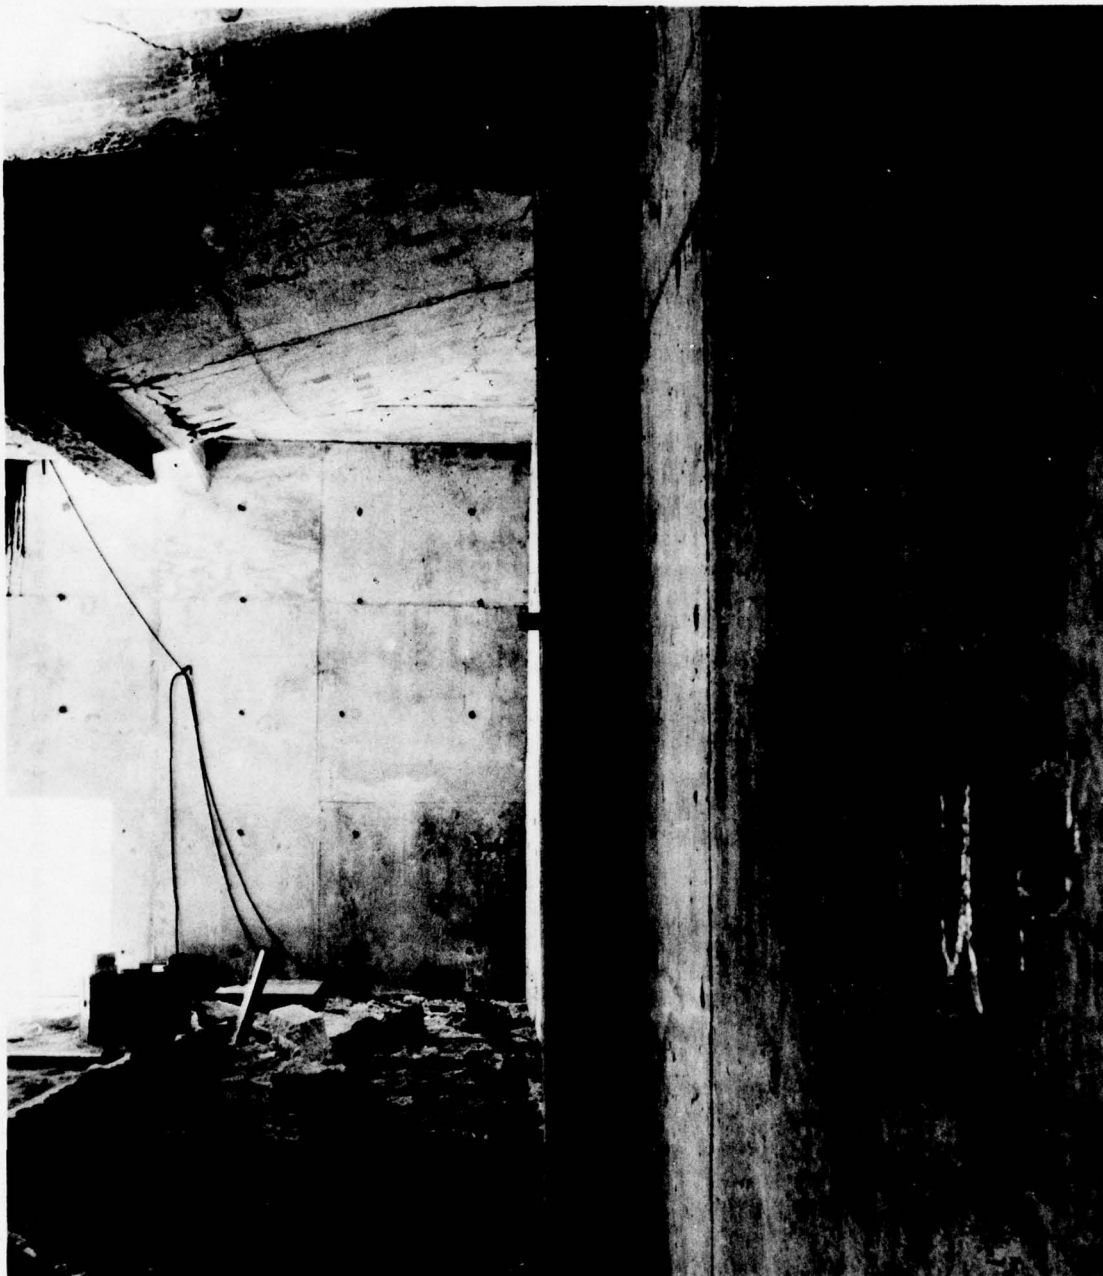
Fig. 6.112 Detail View of Rotation of Haunch at Rear Wall

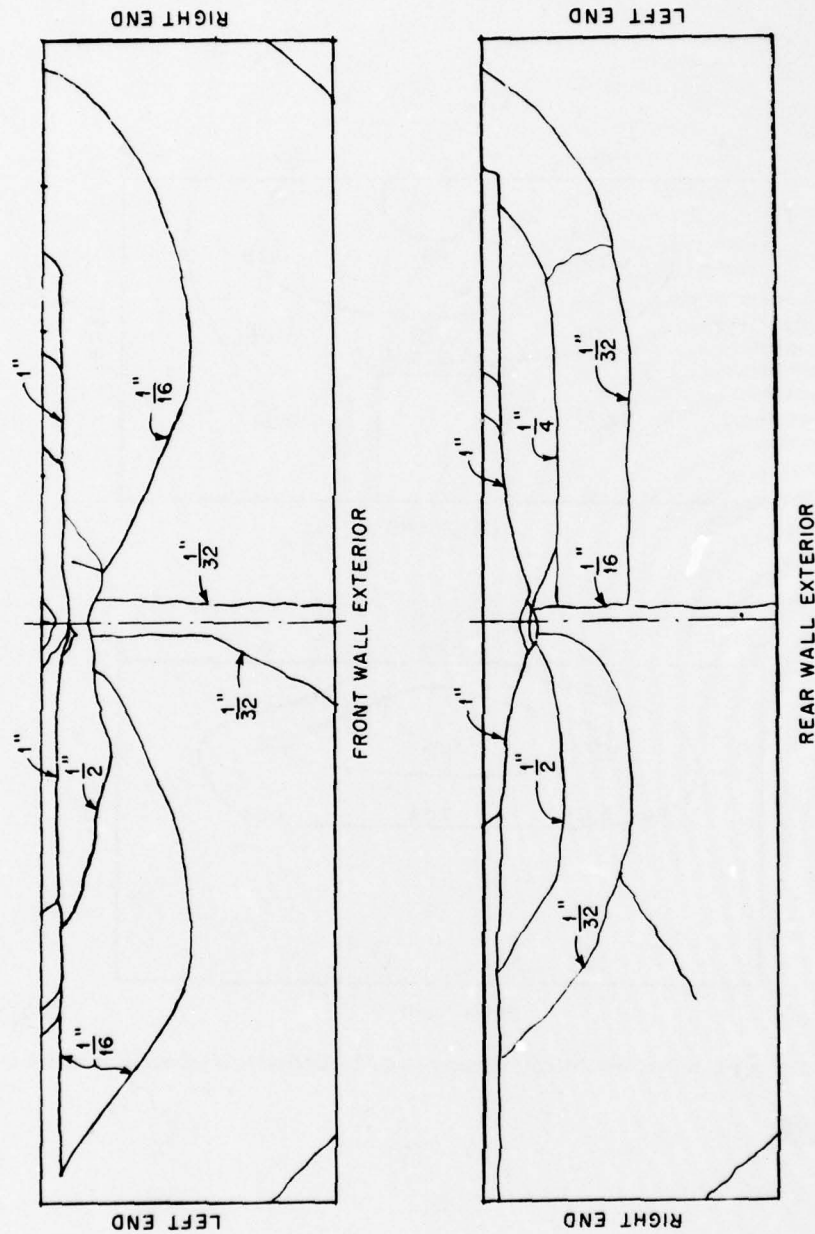
Fig. 6.118 Crack Pattern, Structure 3.2.7b

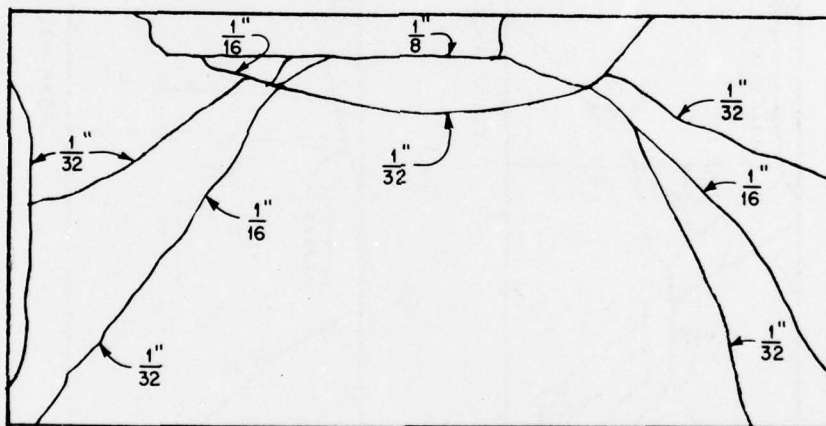
Fig. 6.119 Crack Pattern, Structure 3.2.7b

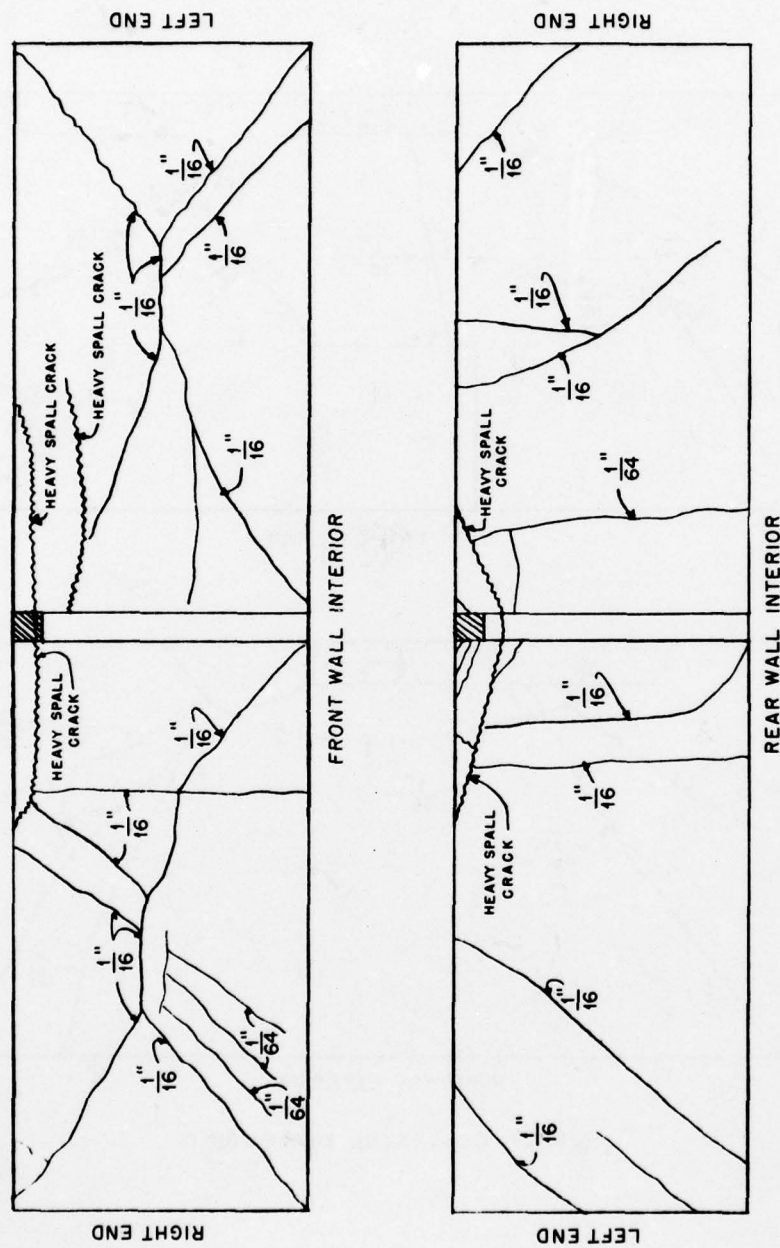
Fig. 6.120 Crack Pattern, Structure 3.2.7b

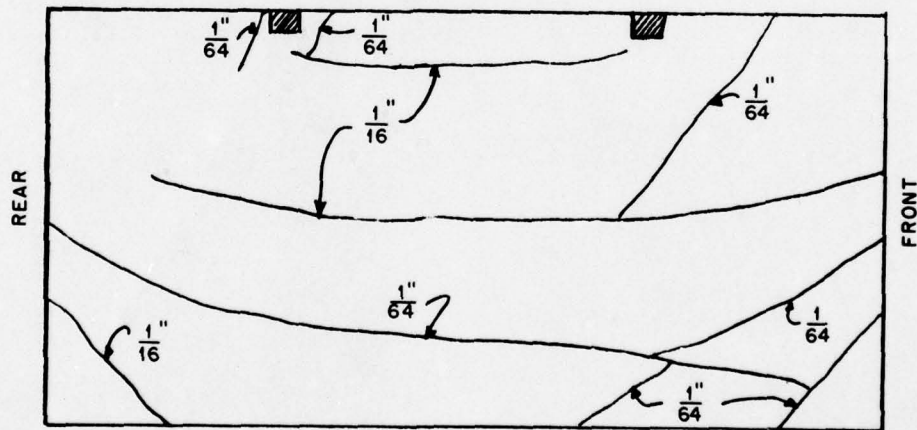
Fig. 6.121 Crack Pattern, Structure 3.2.7b

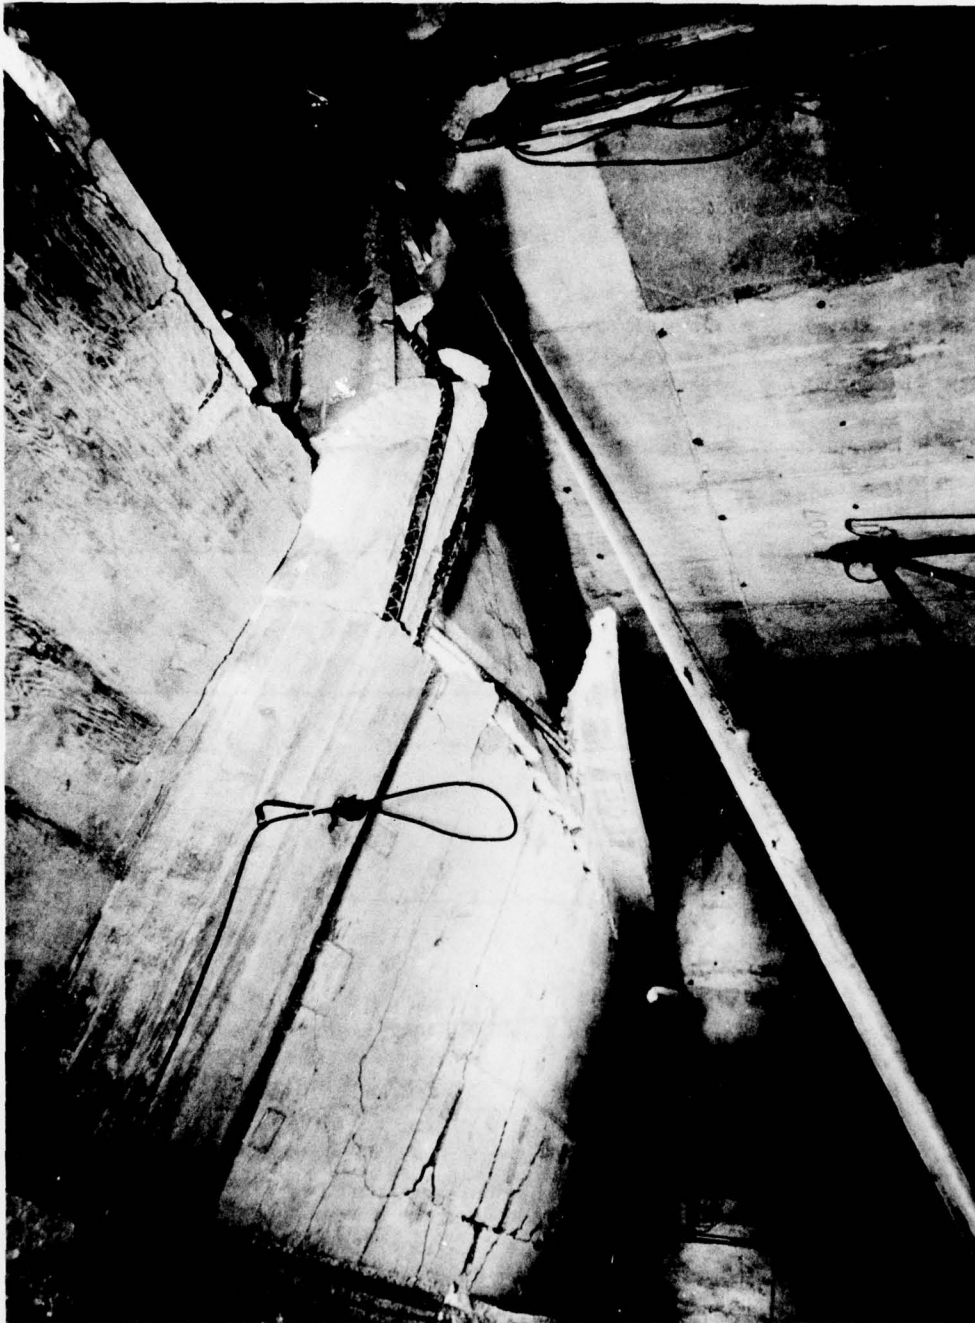
Fig. 6.122 Diagonal Shear Failure in Roof Girder

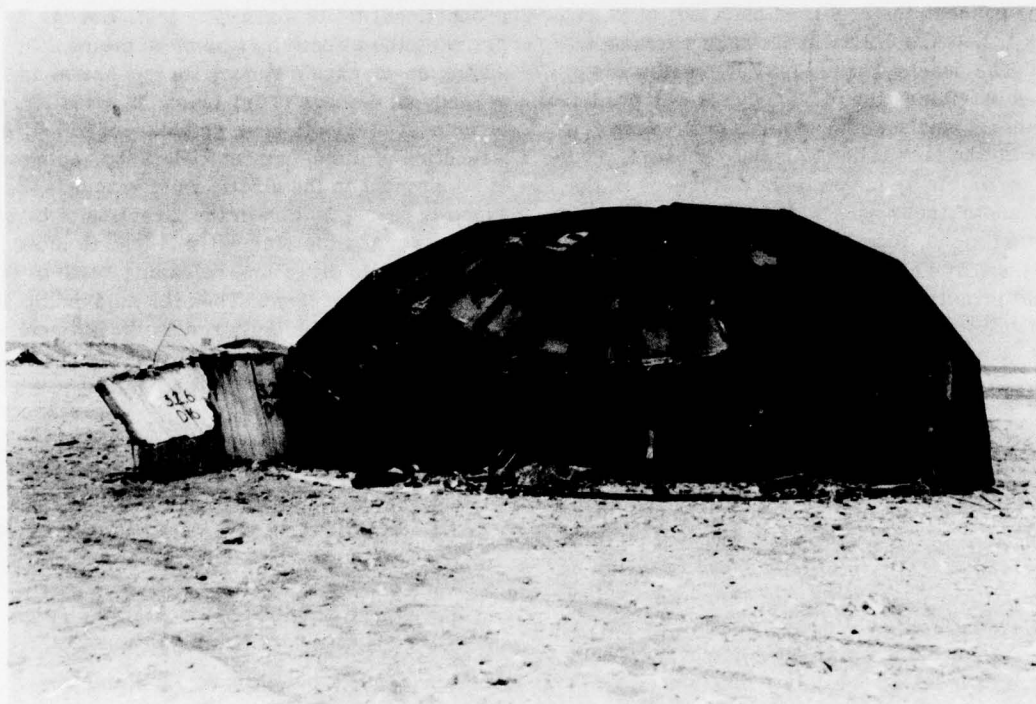
Fig. 7.9 Damage to Structure 3.2.6 After Item Shot, Looking from Direction of Blast
